Subject Installation of Upfitter (AUX) Switches

Models Chevrolet Silverado

Affected GMC Sierra

UI Bulletin #193d

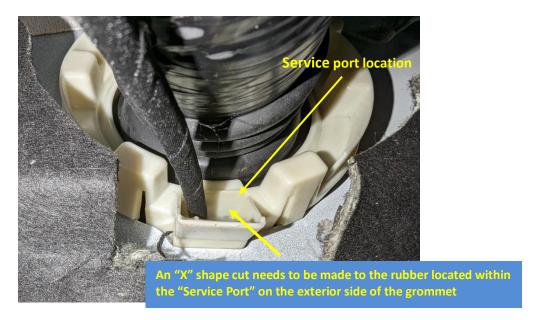
The "service port" or wire pass-thru is located at the 6 o'clock position on the wire harness grommet as shown below. The rubber seal inside of the service port will need to have an "X" cut into to provide for the wire to be passed.

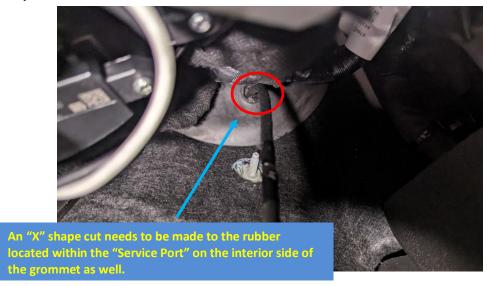
A similar "X" shape cut must be made to the interior cabin side of the grommet located under the IP on the RH side just below the HVAC module—see below

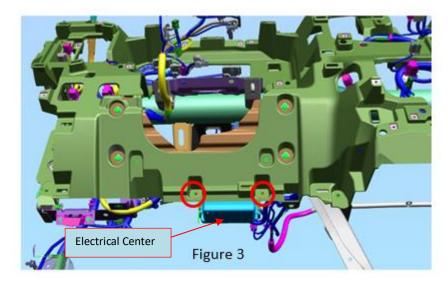
1. Mount the IP Aux. Fuse block using the 2 screws in the locations circled in RED as shown in figure 3

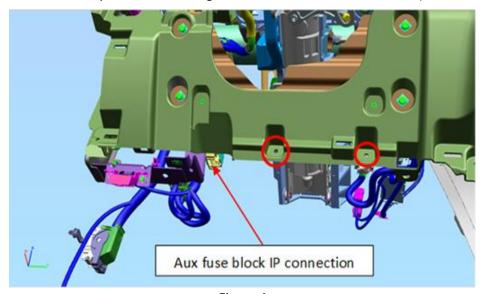
Figure 4

Connect the 14-pin connector Aux Fuse Block to the connector shown in figure 4 (note vehicle is shipped from the assembly plant with a blank connector in place to protect the terminals in the IP Harness. Remove this prior to connecting the connector from the fuse block)

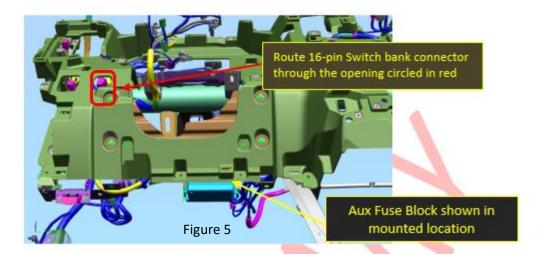
2. Route the 16-pin switch bank connector through the opening in the Instrument Panel as shown in figure 5

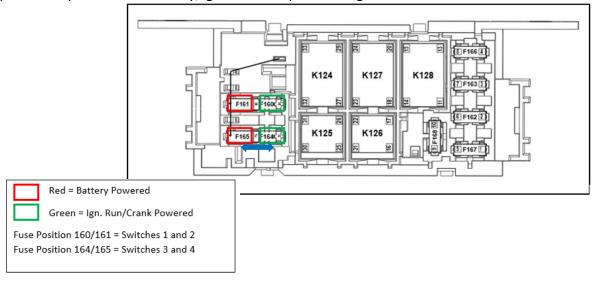
The upfitter switches are defaulted to being battery powered but can be reconfigured in pairs to operate only when in accessory/ignition ON by relocating one or two fuses as shown below.
