# UI Bulletin #204

**Subject:** Installing Tahoe PPV/SSV Emergency Lighting and Aftermarket Equipment - Liftgate Struts Warning  
**Models Years** All Model Years  
**Affected:**  
**Models** TAHOE 9C1 PPV  
**Affected**  
**Origination** 9/25/2024  
**Date:**  
**Revision**  
**Date:** N/A

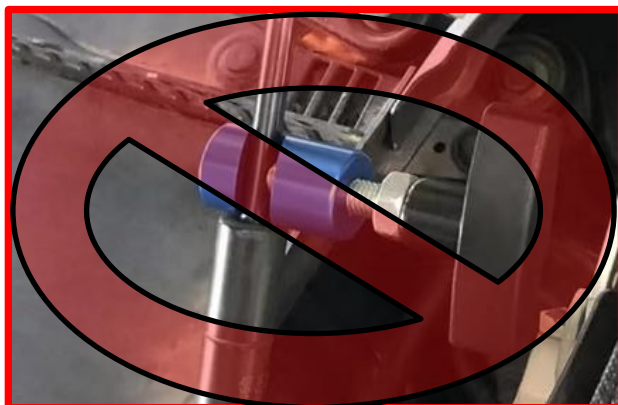
### NOT ACCEPTABLE EXAMPLE

Some Customers, Upfitters, or Dealers installing Tahoe Rear Strobes that need to remove the rear struts CANNOT clamp on the struts to hold open the liftgate. Use of a clamping device could damage the liftgate strut rod seals.

**WARNING:** When a liftgate hold open device is being removed or installed, provide alternate support to avoid possibility of damage to the vehicle or personal injury.

**CAUTION:** Apply pressure only at the end of the liftgate assist rod that you are removing or attaching. Do NOT apply pressure to the middle of the rod because damage or bending will result.
