Subject Installation of Upfitter (AUX) Switches

Models Chevrolet Silverado

Affected GMC Sierra

UI Bulletin #193d

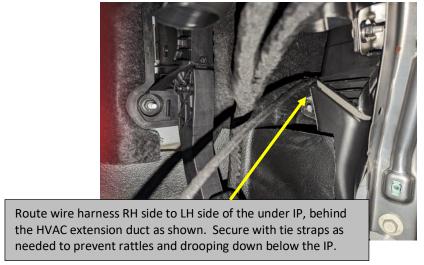
NOTE: For all vehicle trim level applications the components shown below will need to be installed

Knee Bolster	Switch Bank	Fuse kit	Aux. Fuse Block + Switch harness	Wire Harness	Fasteners
P/N	84487354	84688687	84669070	86812138	84794790	11589015
