**Subject:** Installation of Upfitter (AUX) Switches (9L7) components  
**Models Years** 2024-Current  
**Affected:**  
**Models Affected** Full-size GMC Trucks – Premium Uplevel Trim  
Denali/Ultimate/AT4/AT4X  
**Origination Date:** 10/24/2024  
**Revision Date:** N/A

### Install Procedure #3 = AT4 (GFG), AT4X (GA4), Denali (GFW), Denali Ult (GFY)

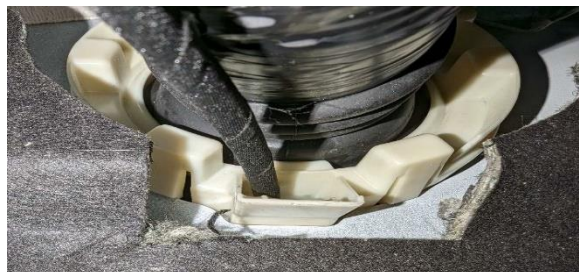
Prior to attempting to pass the wire/harness into the cabin the silver-colored insulation and plastic conduit must be removed, leaving only fabric like tape wrapping on the wire.

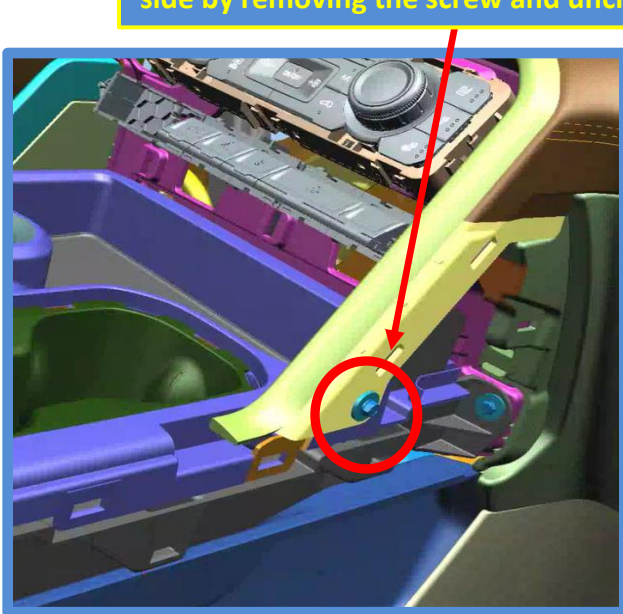
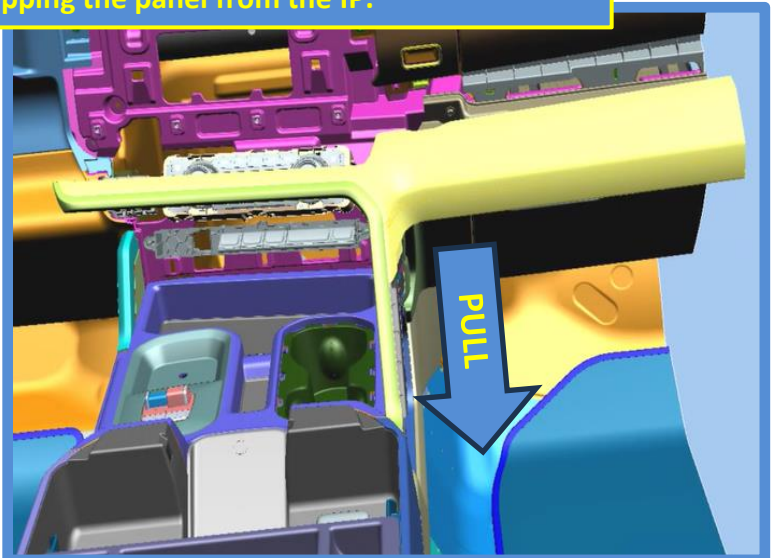
Next you need to remove the lower console trim panels on both left and right side by removing the screw and unclipping the panel from the IP.

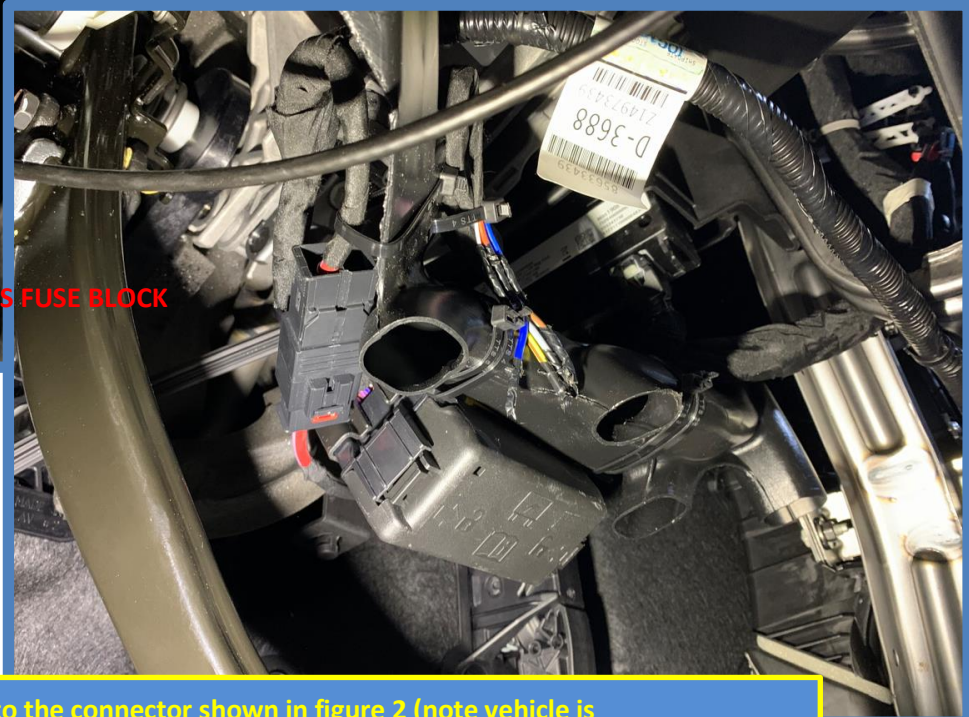
2. Mount the IP Aux. Fuse block using Zip ties on the front(engine side) of the driver's side HVAC extension duct under IP. Where the harness exits the aux fuse block, it should face toward drivers' outboard side, when the fuse block is mounted on the driver's side HVAC extension duct. Remove the u-nuts from the mounting ears of the aux fuse block. Apply two-sided tape to the aux fuse block, spanning between the two mounting ears. Insert a zip tie thru the hole for each of the mounting ears. Position the aux fuse block to the front (engine side) of the driver's side HVAC extension duct as shown, then secure the two-sided tape and zip ties. Add two additional zip ties, one on each mounting ear, positioned between the first zip ties and the body of the fuse block, as shown below.

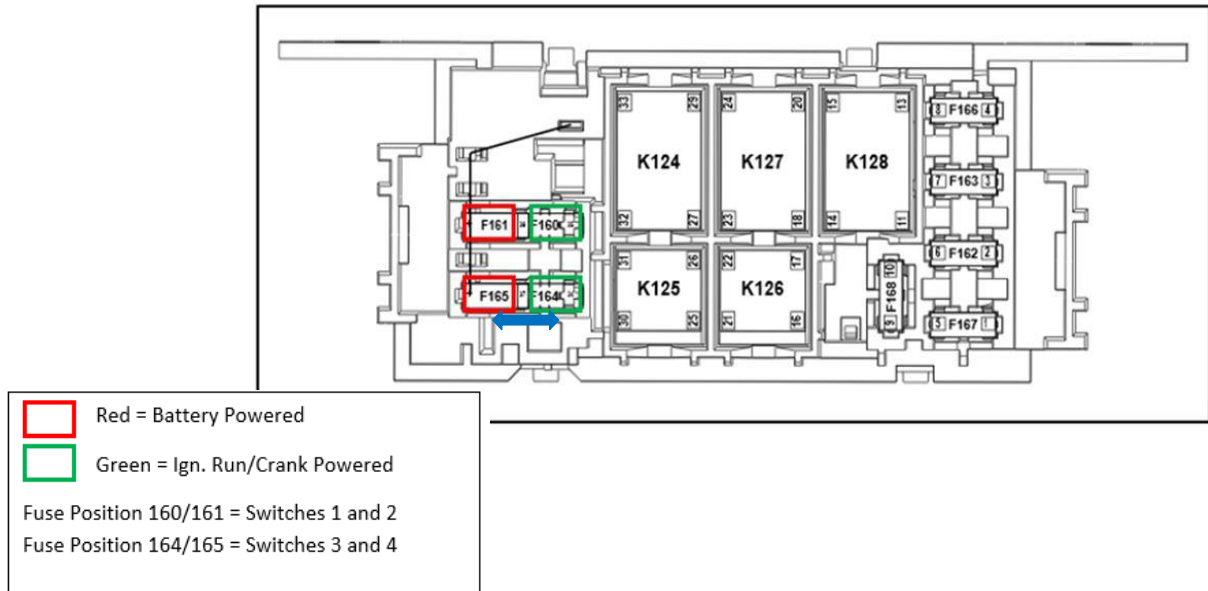
The upfitter switches are defaulted to being battery powered but can be reconfigured in pairs to operate only when in accessory/ignition ON by relocating one or two fuses as shown below.
