Subject: Installation of Upfitter (AUX) Switches (9L7) components
Models Years 2024-Current
Affected:
Models Affected Full-size GMC Trucks – Premium Uplevel Trim
Denali/Ultimate/AT4/AT4X
Origination Date: 10/24/2024
Revision Date: N/A

Install Procedure #3 = AT4 (GFG), AT4X (GA4), Denali (GFW), Denali Ult (GFY) - UI TSB 205

Install Procedure #3 = AT4 (GFG), AT4X (GA4), Denali (GFW), Denali Ult (GFY)

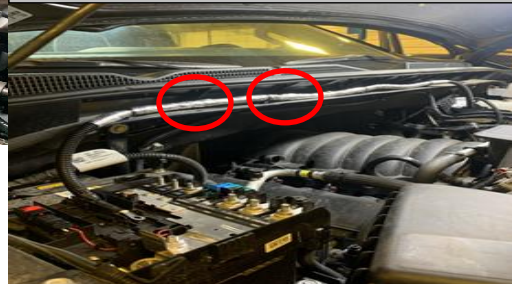
To run the power harness to the fuse block two 6mm holes, need to be drilled to add access for retainer clip on these Denali and AT4 trucks. The holes are in the sheet metal but not in the plastic.

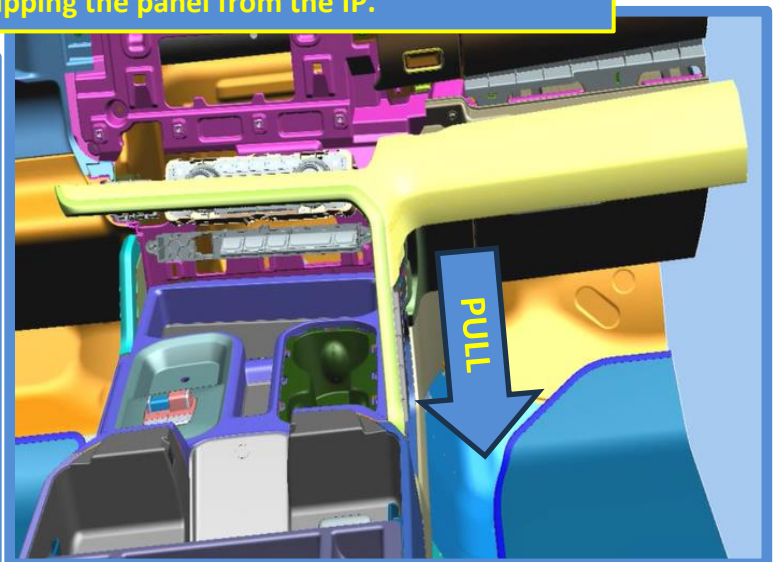
Next you need to remove the lower console trim panels on both left and right side by removing the screw and unclipping the panel from the IP.

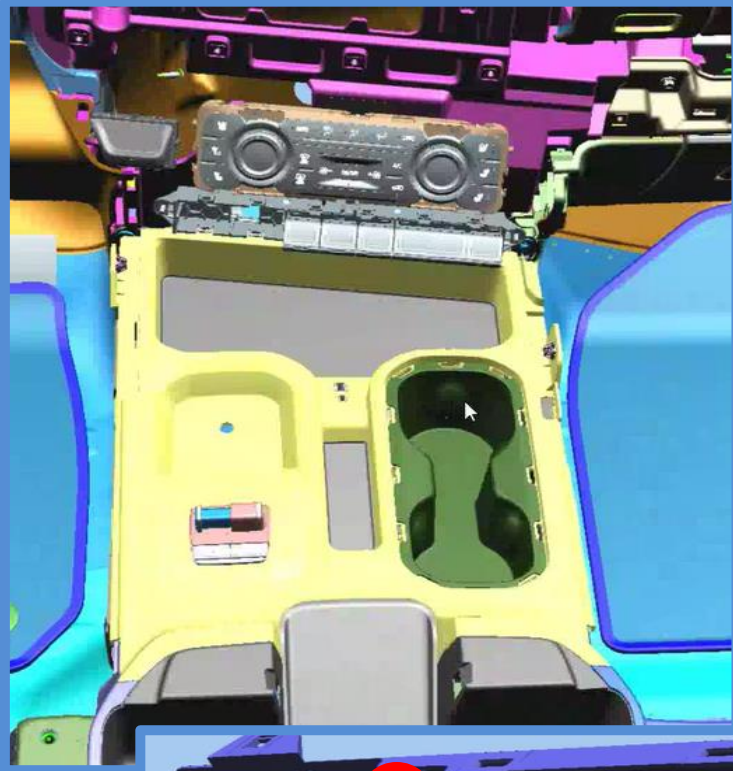
When removing the Console panel, there are ten(10) retainer clips holding down this panel. Use a flat-bladed plastic trim tool. Caution when lifting as the USB, trailer brake controller, ignition lock key antenna, low frequency console antenna etc. will be attached. Disconnect Electrical connectors and release wiring harness retainers.
